# New York State Department of Transportation

## Yellow Flag NB2222W001

**BIN:** 1065318  
**Feature Carried:** 278I278IX2M23027  
**Feature Crossed:** 6TH AVENUE  
**Orientation:** 8 - NORTHWEST  
**Region:** 11 - NEW YORK CITY  
**County:** KINGS  
**Political Unit:** City of NEW YORK  
**Approximate Year Built:** 1962  
**Posted Load Matches Inventory :** Yes  
**Bridge Load Posting (Tons) :** Not Posted for Load  
**Primary Owner:** New York State Department of Transportation  
**Primary Maintenance Responsibility:** 12 - State - Subcontracted to another Party  
**Typical or Main Span Type:** 3 - Steel, 02 - Stringer/Multi-Beam or Girder  
This Bridge is not a Ramp  
**Number of Spans:** 322

Location: Span 220, Girder G19 at Pier 220

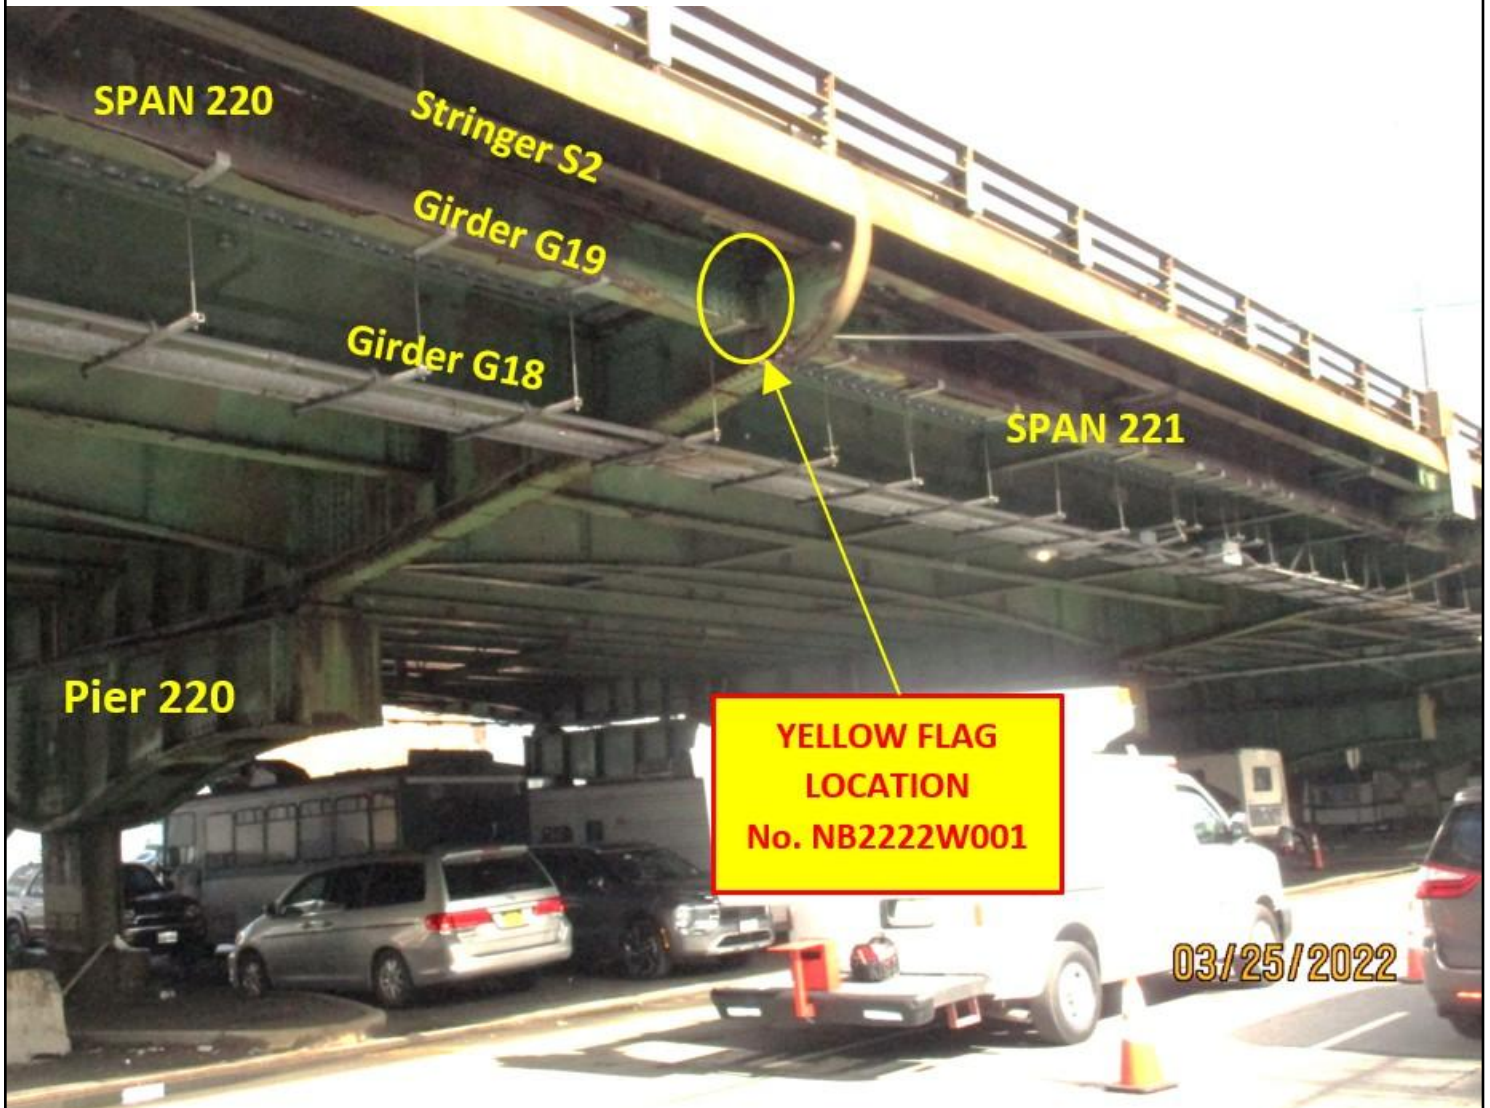
Photo Number: 1

Description: The right connection angle at Girder G19 connection to the pier cap at Pier 220 exhibits a 4"H x ½" W vertical corrosion crack at the upper fillet section, 5"H x ½" W vertical corrosion crack at the center and 1.75"H x ½" W vertical corrosion crack at the lower fillet section. All with no significant changes from the previous inspection (Photos 2 and 3). The remaining 3.5" of the connection angle height exhibits up to 90% section loss (no change from previous).

**Attachment Description:** Span 220, Girder G19 at Pier 220. General view of crack location at pier cap connection. Looking end left.

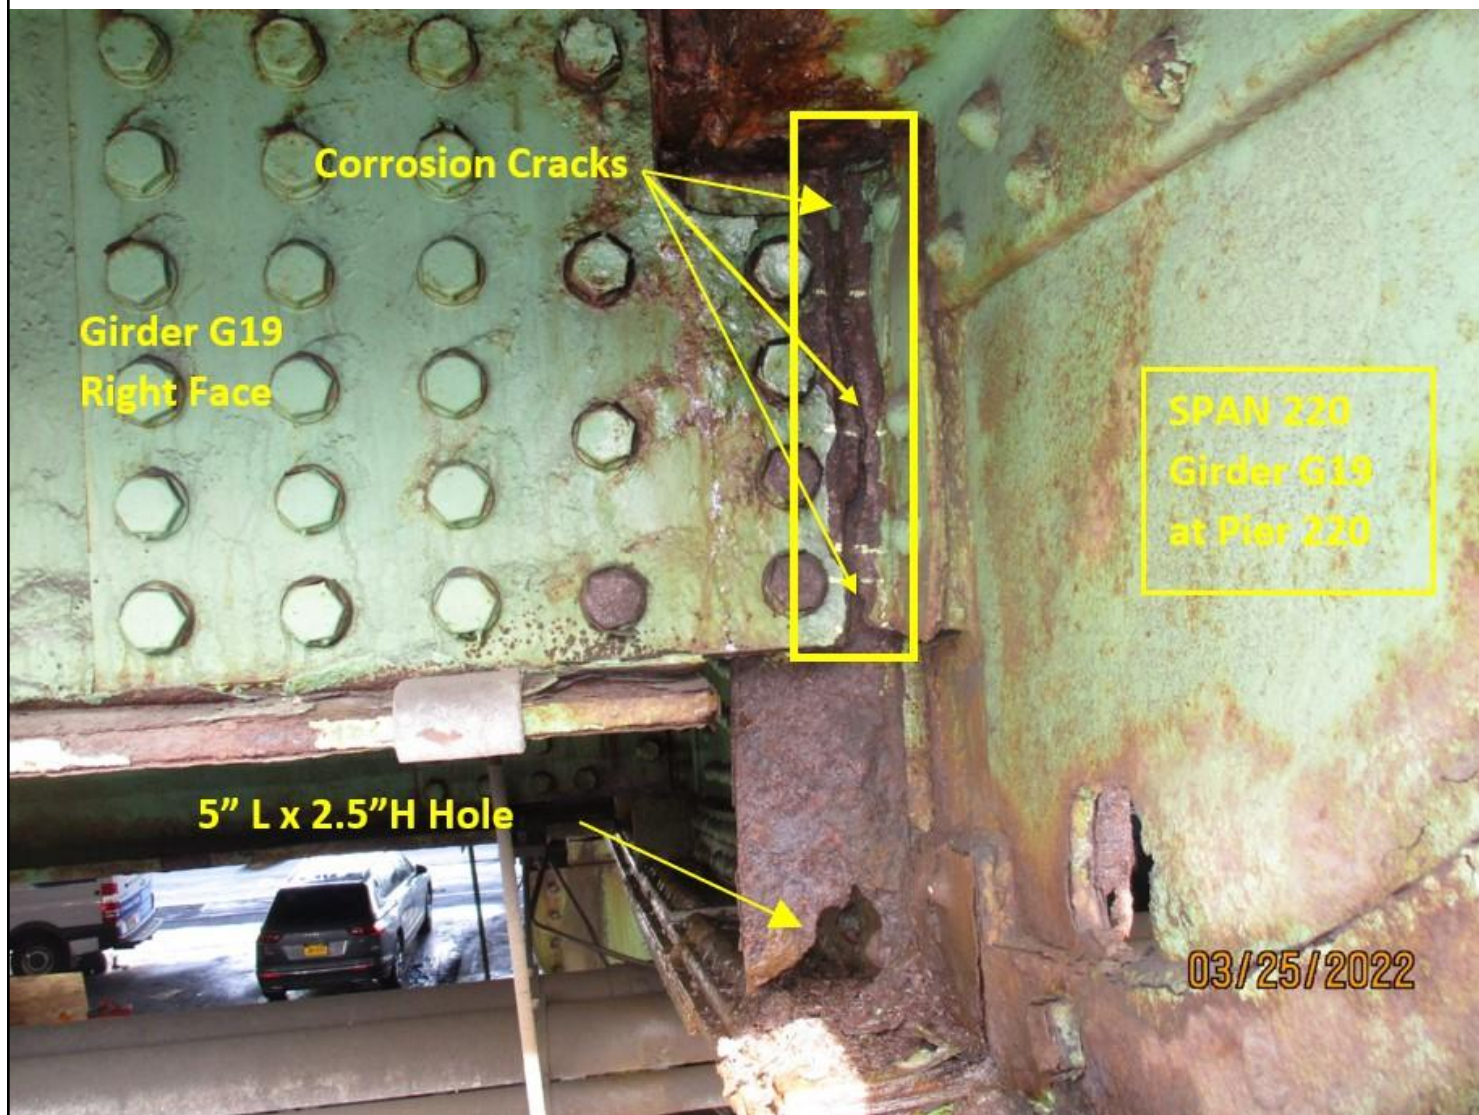
Photo Number: 2

The left connection angle exhibits two corrosion holes at the top measuring 3" W x 1"H and ½" W x 1"H (no change from previous) (Photo 4). Additionally, there is a 5" L x 2.5" H corrosion hole at the base of the angle (previously noted to be 3.75"L x 2.5"H) (Photo 2). The remaining area of the left connection angle exhibits up to 30% section loss.

**Attachment Description:** Span 220, Girder G19 at Pier 220. General view of the flagged location showing severe corrosion and cracking in the right connection angle of the girder to the pier cap and corrosion hole at the base of the connection angle. Looking left.

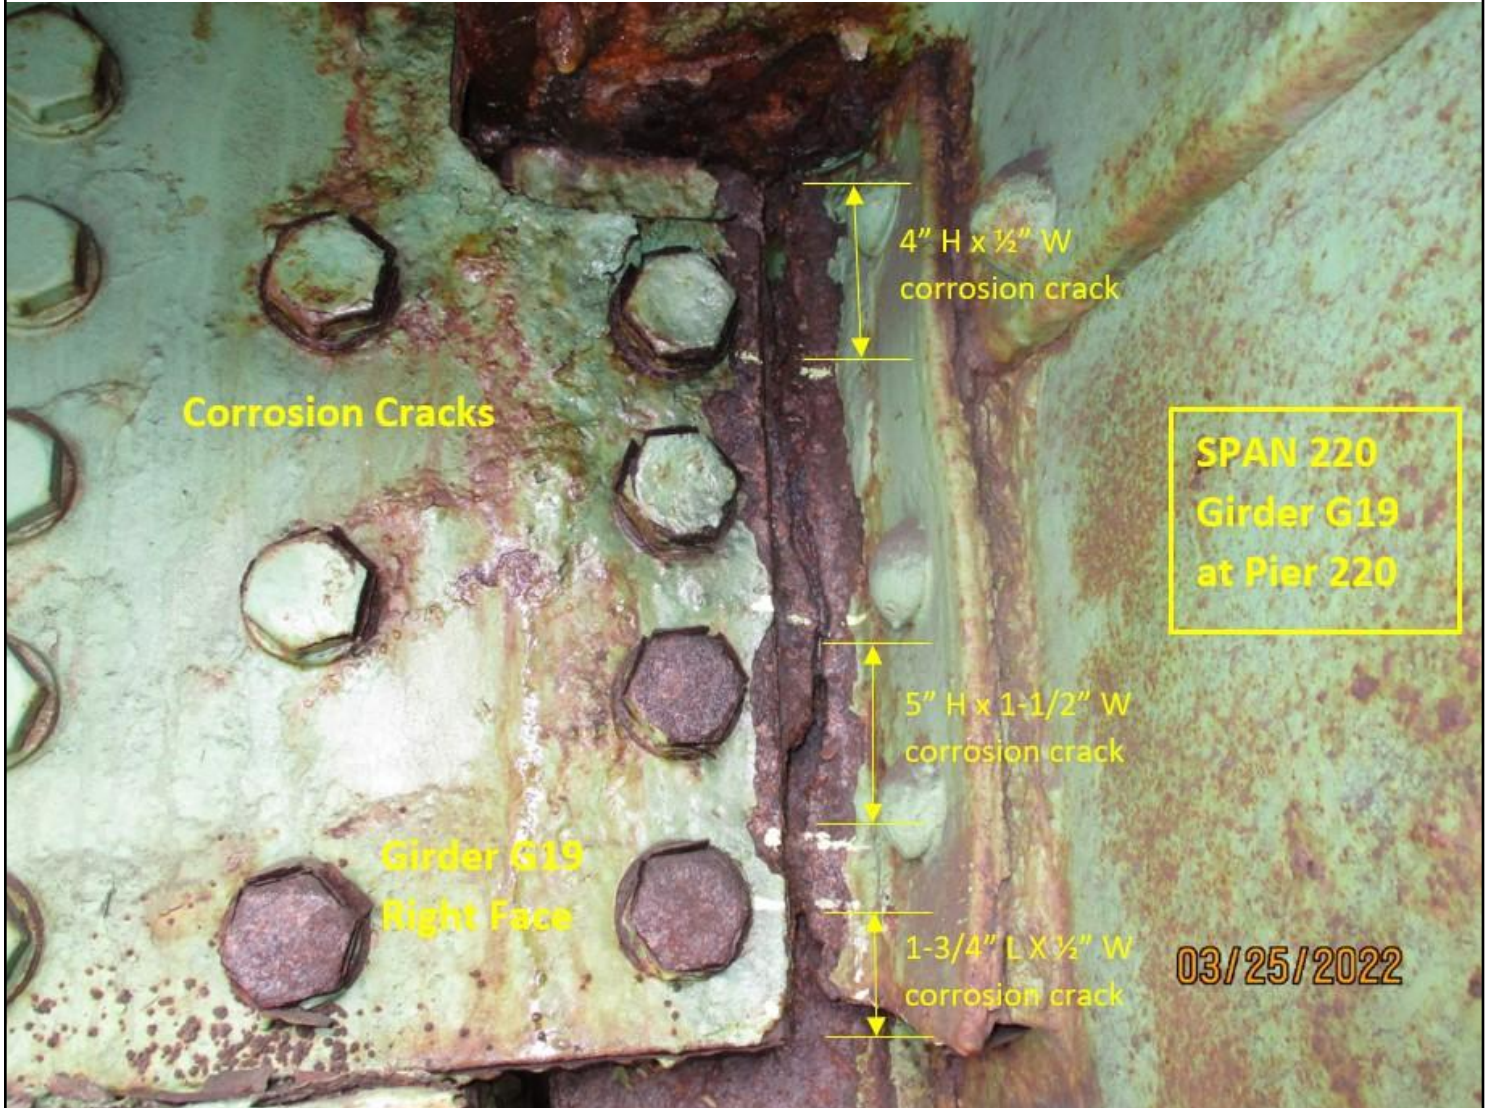
Photo Number: 3

**Attachment Description:** Span 220, Girder G19 at Pier 220. Close-up view of the flagged location showing severe corrosion and cracking in the right connection angle of the girder to the pier cap. Looking left.

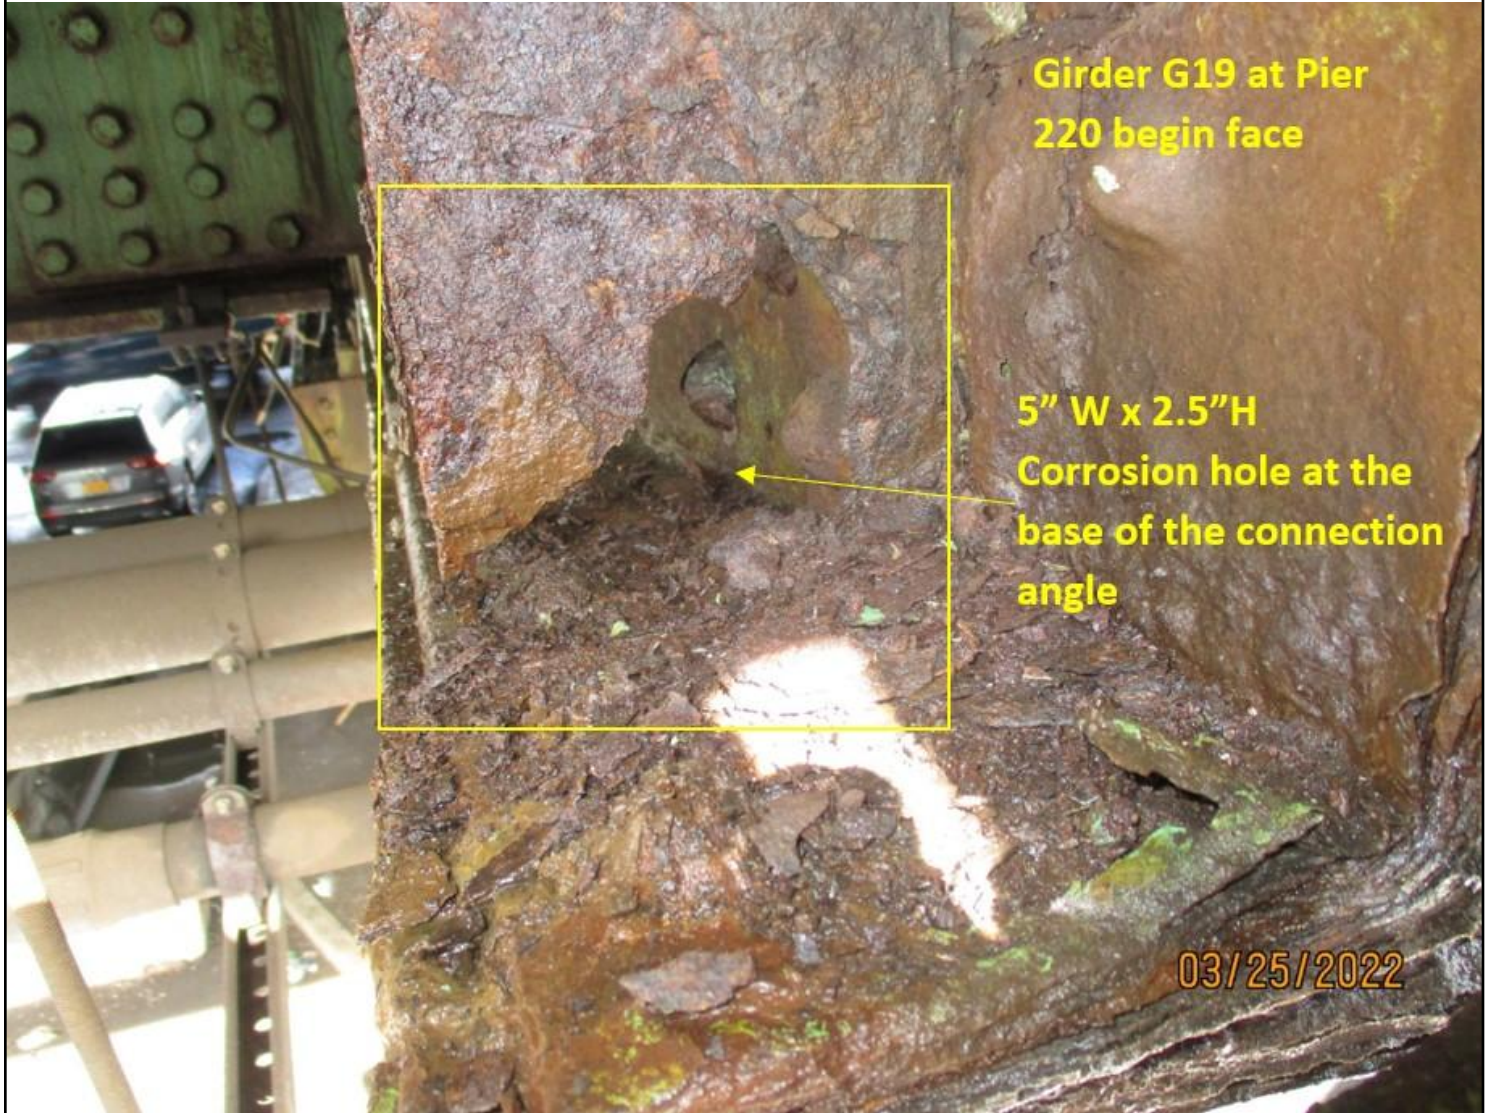
Photo Number: 4

**Attachment Description:** Span 220, Girder G19 at Pier 220. Close-up view of the flagged location showing 5" L x 2.5"H corrosion hole in the base of the connection angle. Looking left.

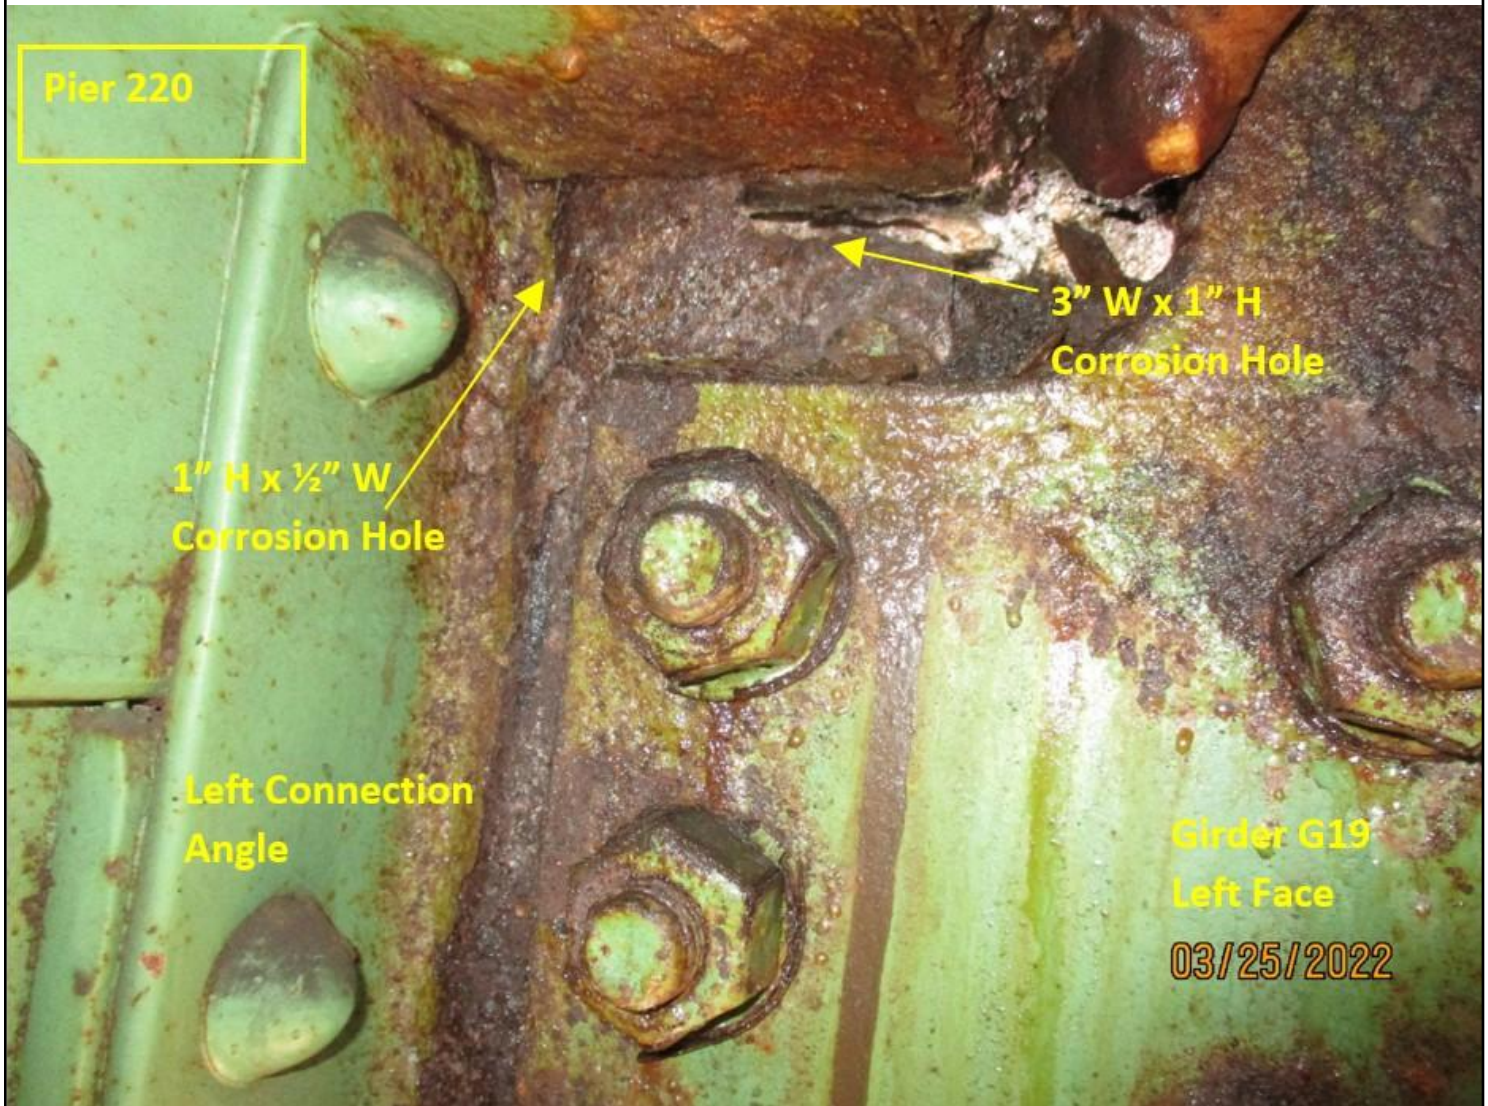
Photo Number: 5

**Attachment Description:** Span 220, Girder G19 at Pier 220. Close-up view of the flagged location showing severe corrosion and cracking in the left connection angle of the girder to the pier cap. Looking end right.

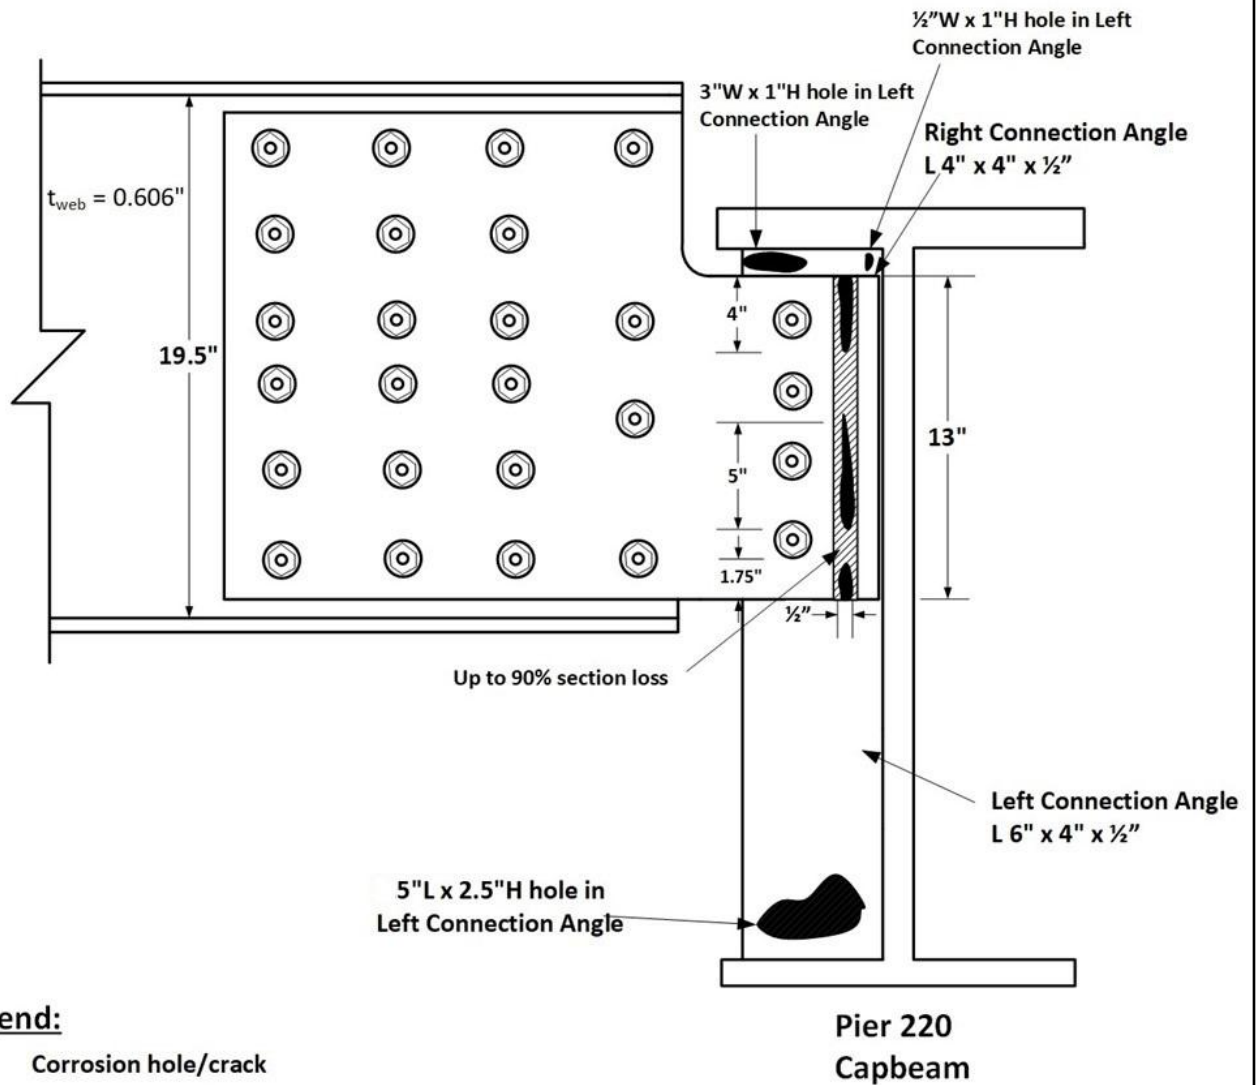
Photo Number: 6

**Attachment Description: NB2222W001 Span 220 G19 at Pier 220 Sketch**

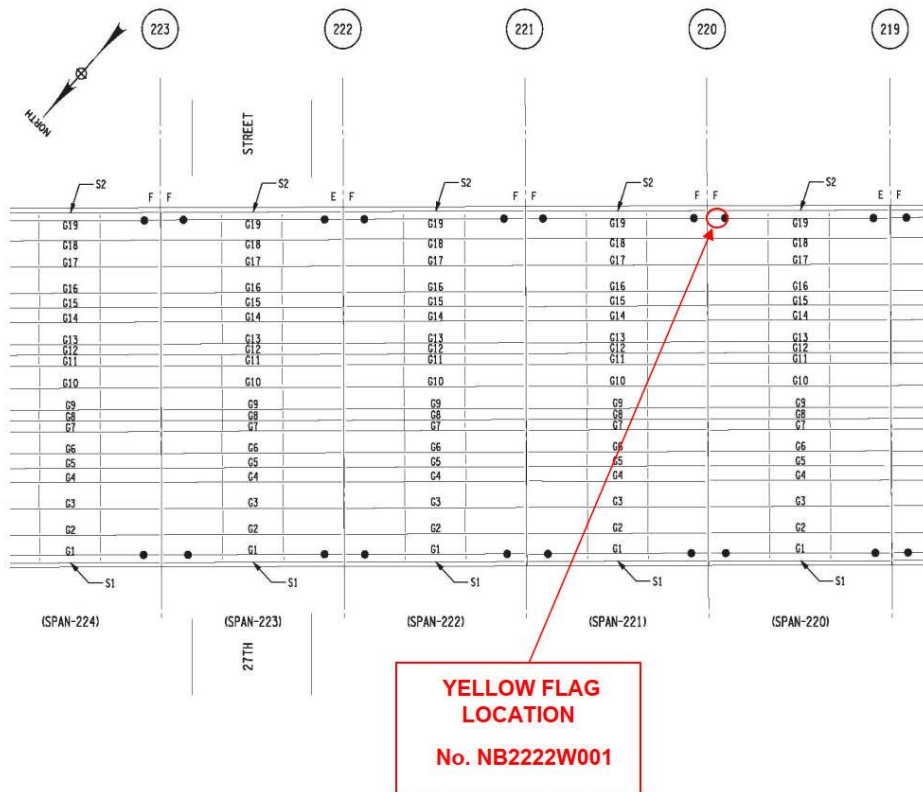
Photo Number: 7

**Attachment Description: NB2222W001 Span 220 G19 at Pier 220 Framing Plan**
